# Local Hazard Mitigation Plan 2023

East Bay Municipal Utility District

The East Bay Municipal Utility District (EBMUD) 2023 Local Hazard Mitigation Plan (2023 LHMP) is an update to its 2018 Local Hazard Mitigation Plan (2018 LHMP) and reflects EBMUD’s most current system upgrades, improvements, and mitigation measures to reduce community exposure to hazards and to improve reliability of its services to the public.

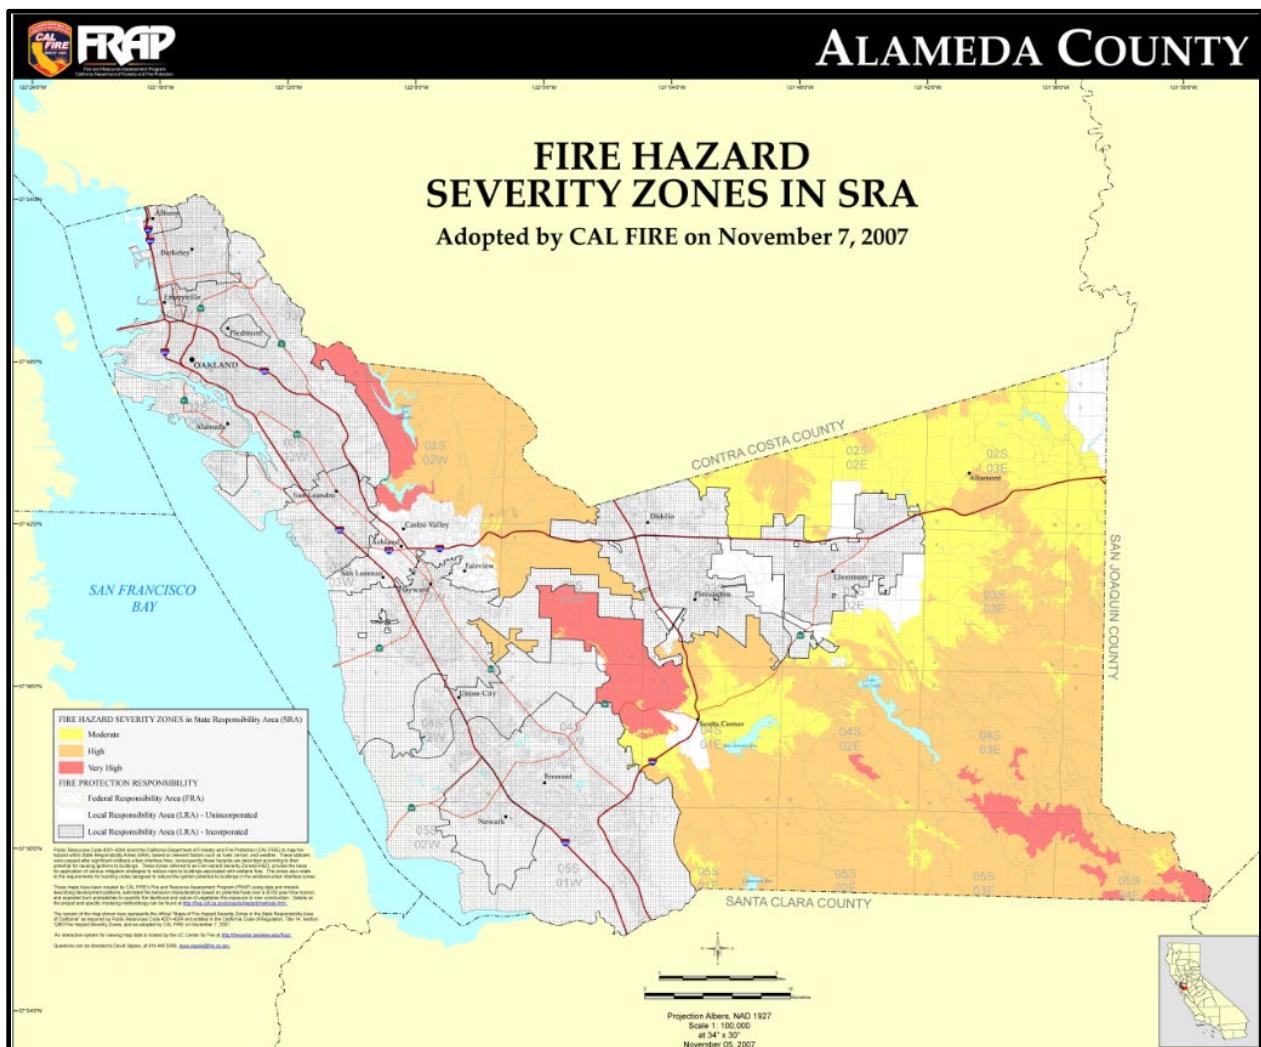
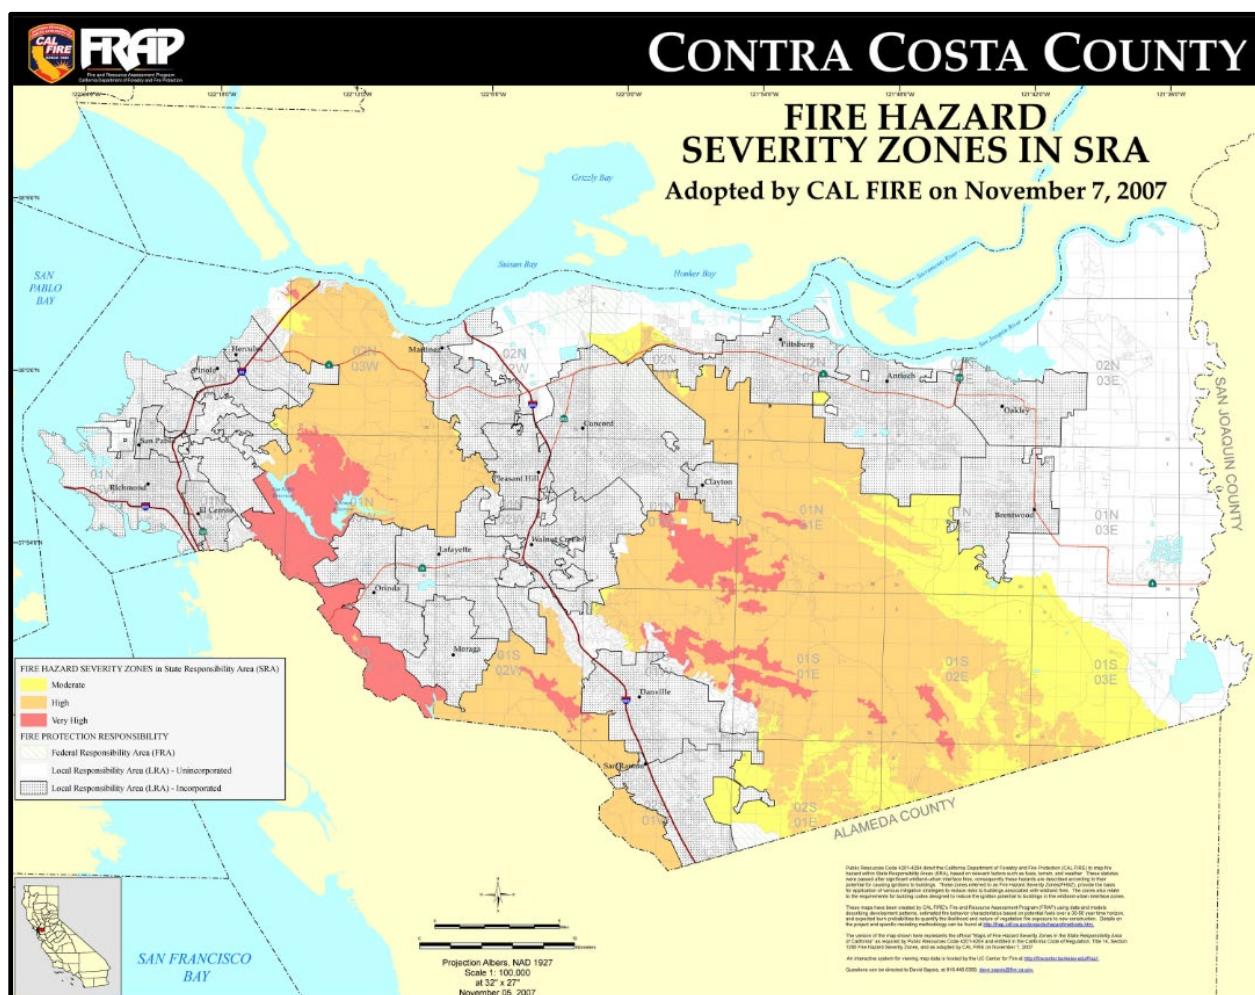
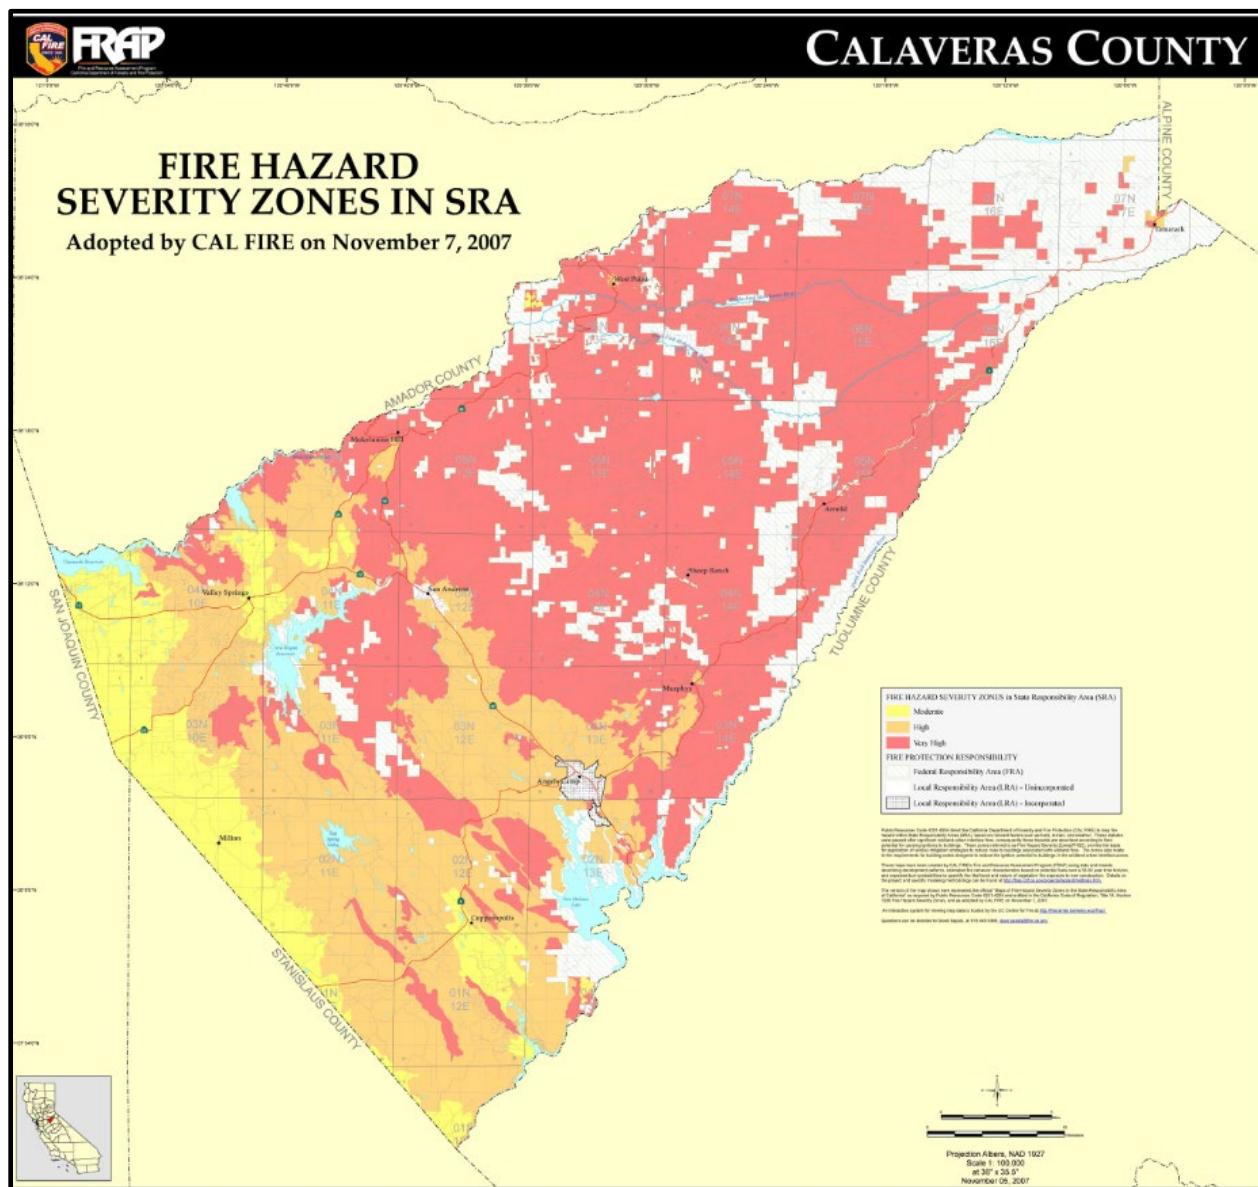
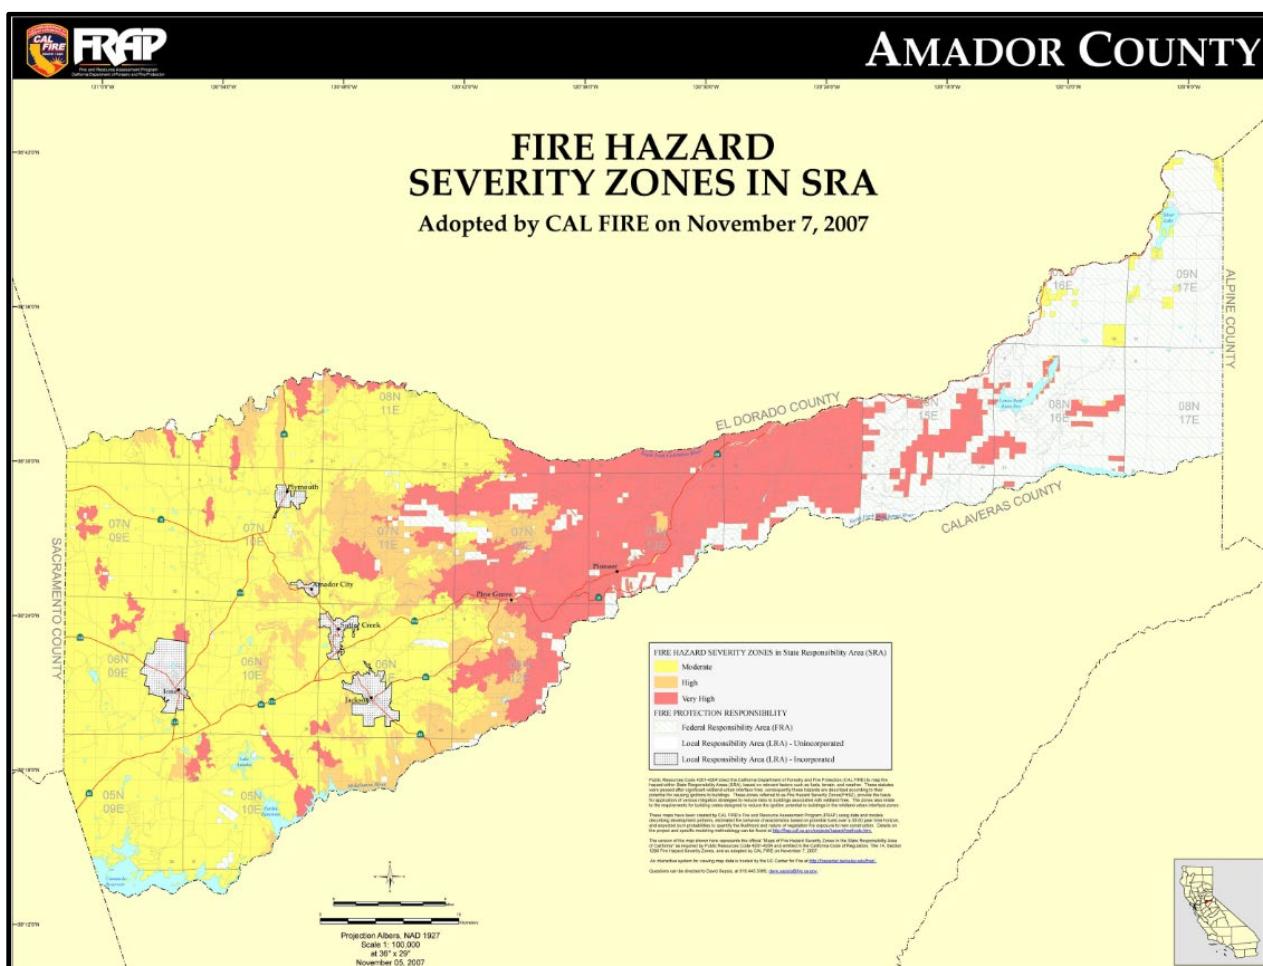
Figure 6.11 through Figure 6.14 show areas adjacent to reservoirs in the EBMUD service boundary (i.e. Briones, San Pablo, and Upper San Leandro) and areas surrounding the Mokelumne River watershed to be in high to very high fire hazard zones. As stated earlier, from 1989 through 2021, EBMUD staff responded to 542 fires in the Mokelumne River watershed within or adjacent to EBMUD property. Therefore, the probability of wildfire in EBMUD service boundary and Mokelumne River watershed is highly likely.

Eight percent (94 of 1,154) of EBMUD facilities are in an area mapped as subject to high wildfire threat, 7 percent (84 of 1,154) are in an area mapped as subject to very high wildfire threat, and none are mapped as subject to an extreme wildfire threat. In addition, 73 percent (839 of 1,154) of EBMUD facilities are within the area mapped by CAL FIRE as within the wildland/urban interface fire threat area.

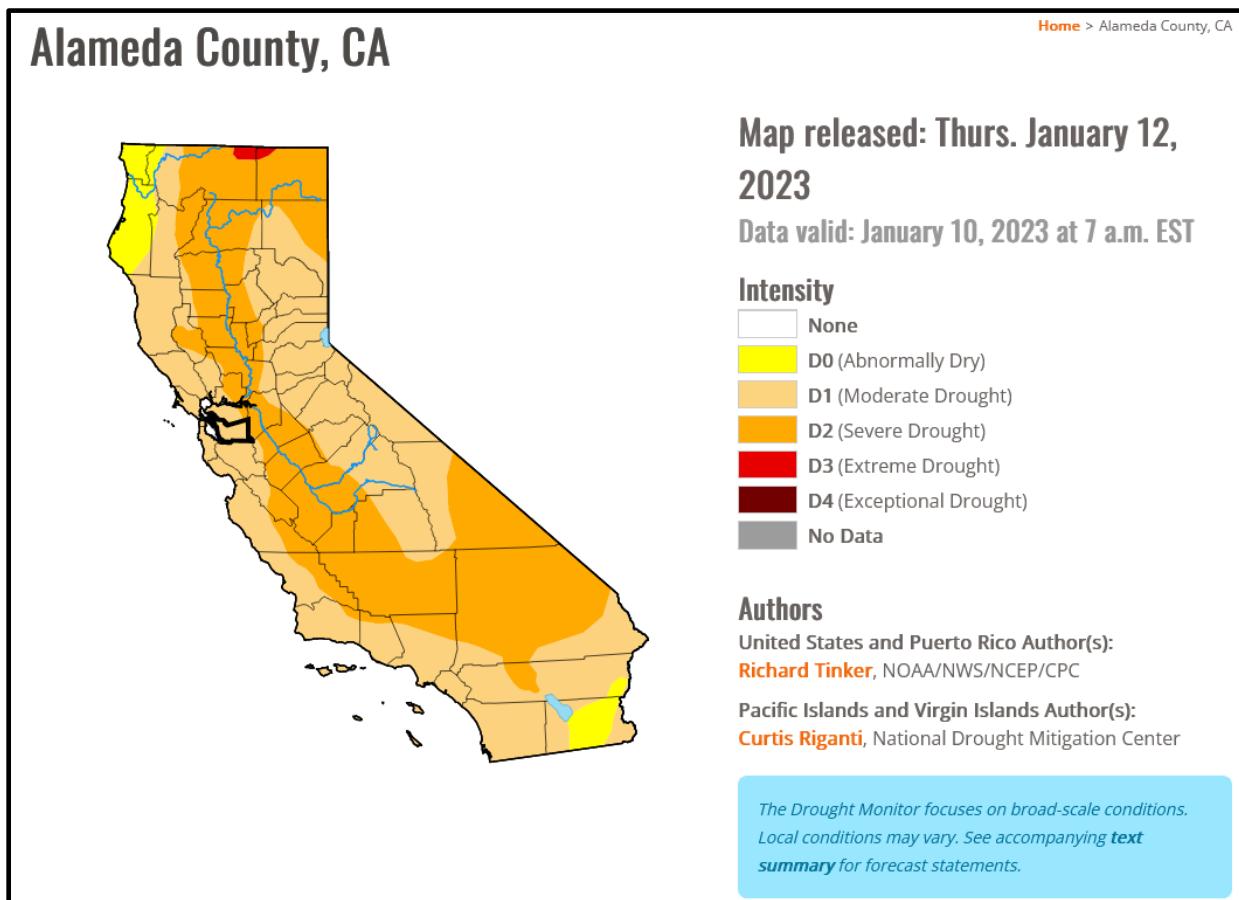
**Figure 6.15. Drought Monitor Map for Alameda County, California January 12, 2023**

Northern California's water resources, including EBMUD's supplies, have historically been affected by periodic drought cycles. The drought hazard affects the whole EBMUD planning area. Multi-year droughts in particular have significantly diminished the supply of water available to EBMUD's customers. The US Drought Monitor publishes up to date measurements of the extent of the drought hazard for Alameda County and the state of California, as shown in Figure 6.15 below.

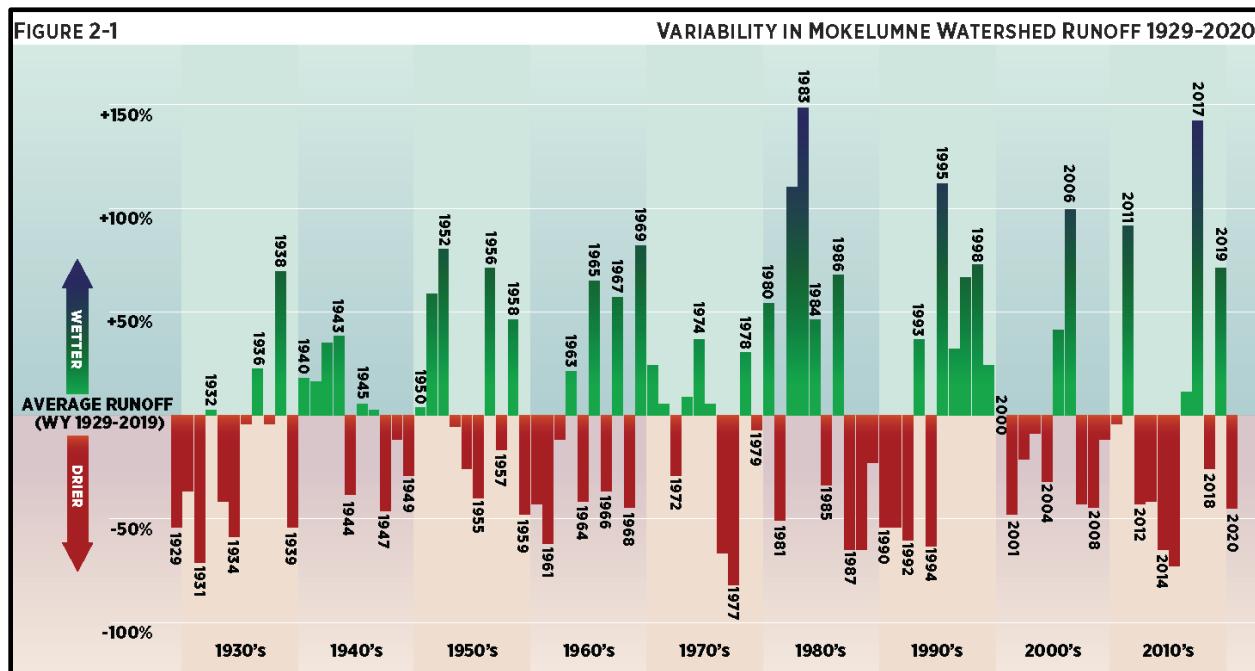
Figure 6.16. Variability in Runoff in the Mokelumne Watershed (1929-2020)

During historical dry periods, when runoff from the Mokelumne River Basin was insufficient to meet service area demands, EBMUD relied on stored water in its reservoirs to meet most of its customer water needs. Figure 6.1621 illustrates the variability in runoff in the Mokelumne River watershed since 1929.

The worst hydrologic drought event in EBMUD history was the 1976-1977 drought, when runoff was only 25 percent of average and total reservoir storage decreased to 39 percent of normal. EBMUD successfully managed water demand during mandatory and voluntary water use reduction periods, when supplies were limited in calendar years 1976-1978, 1987-1994, 2007-2010, and 2014-2016.

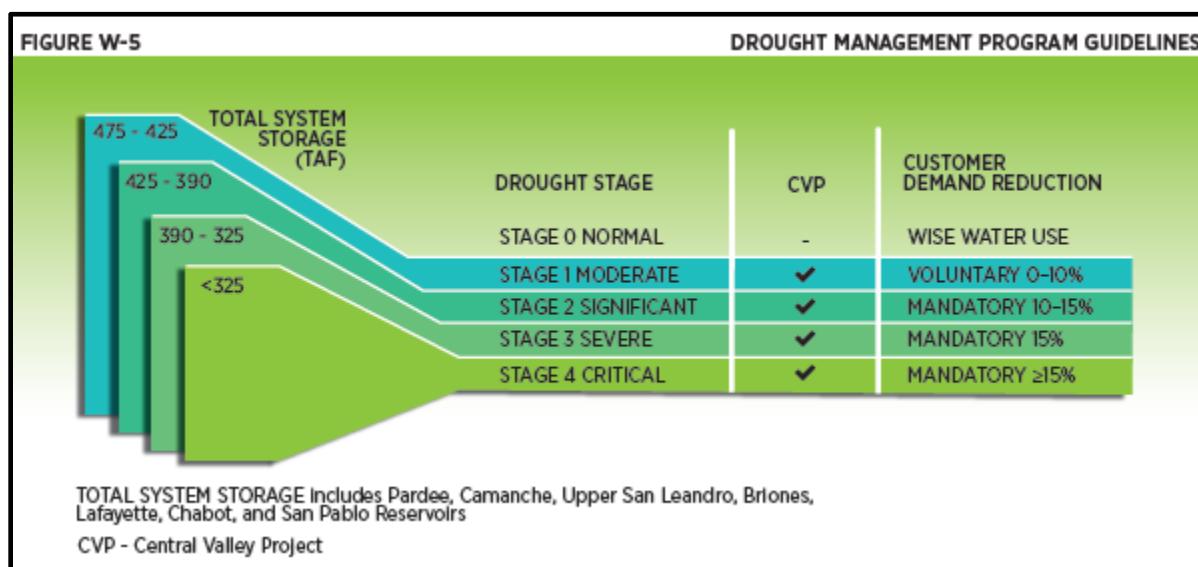
**Figure 6.17. EBMUD's Demand Management Program Guidelines<sup>1</sup>**

For the purposes of estimating drought frequency, EBMUD defines a drought using the projected end-of-September Total System Storage criteria equal to 475 TAF. We can determine the frequency of time above and below this threshold by running EBMUD's water resources planning simulation model (RiverWare) under existing conditions. At this lower trigger, model results show that there are 13 drought years (14 percent or approximately 1.4 in 10 years) over the historical 95-year period of record (January 1921 to September 2015). Under a future condition or demand, this would be 24 years over the period of record.

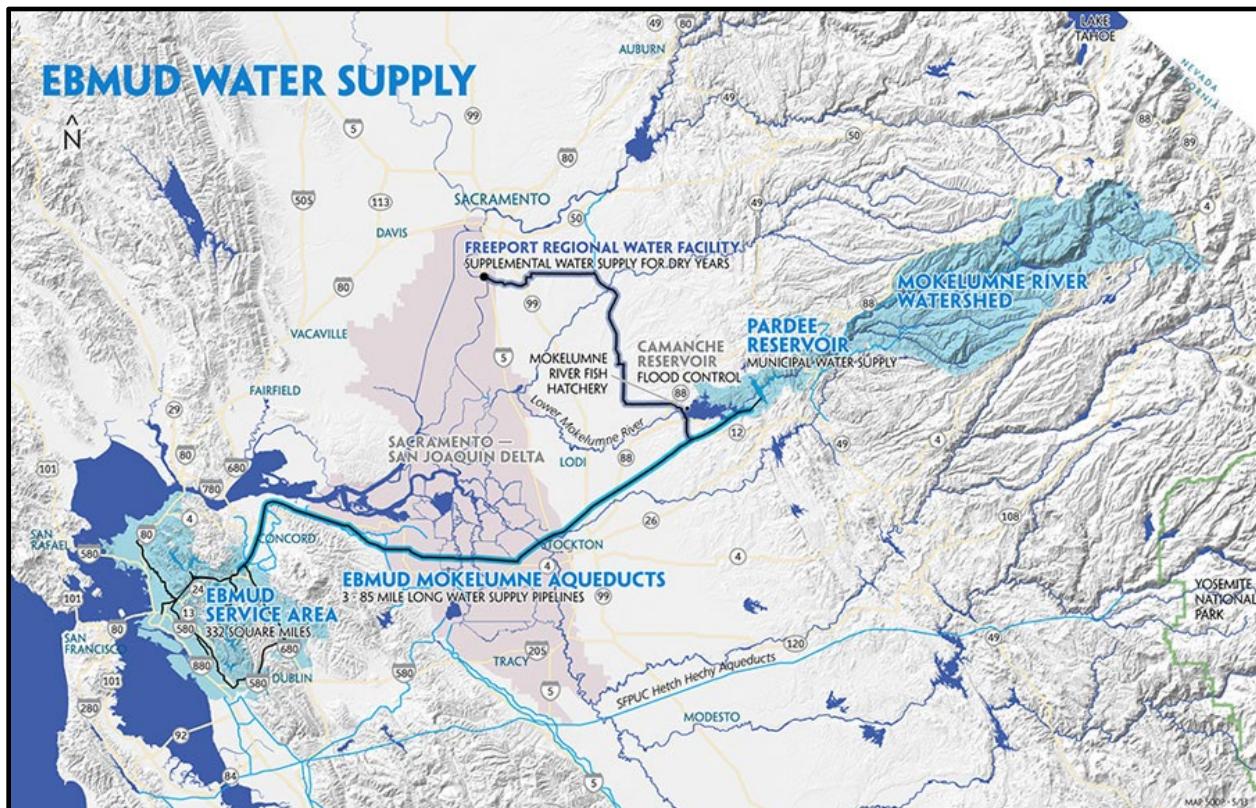
**Figure 11.1. EBMUD Water Supply**

EBMUD's water supply system consists of reservoirs, aqueducts, treatment plants, and distribution facilities from the Mokelumne River Basin in the Sierra Nevada Mountains to the East San Francisco Bay Area.

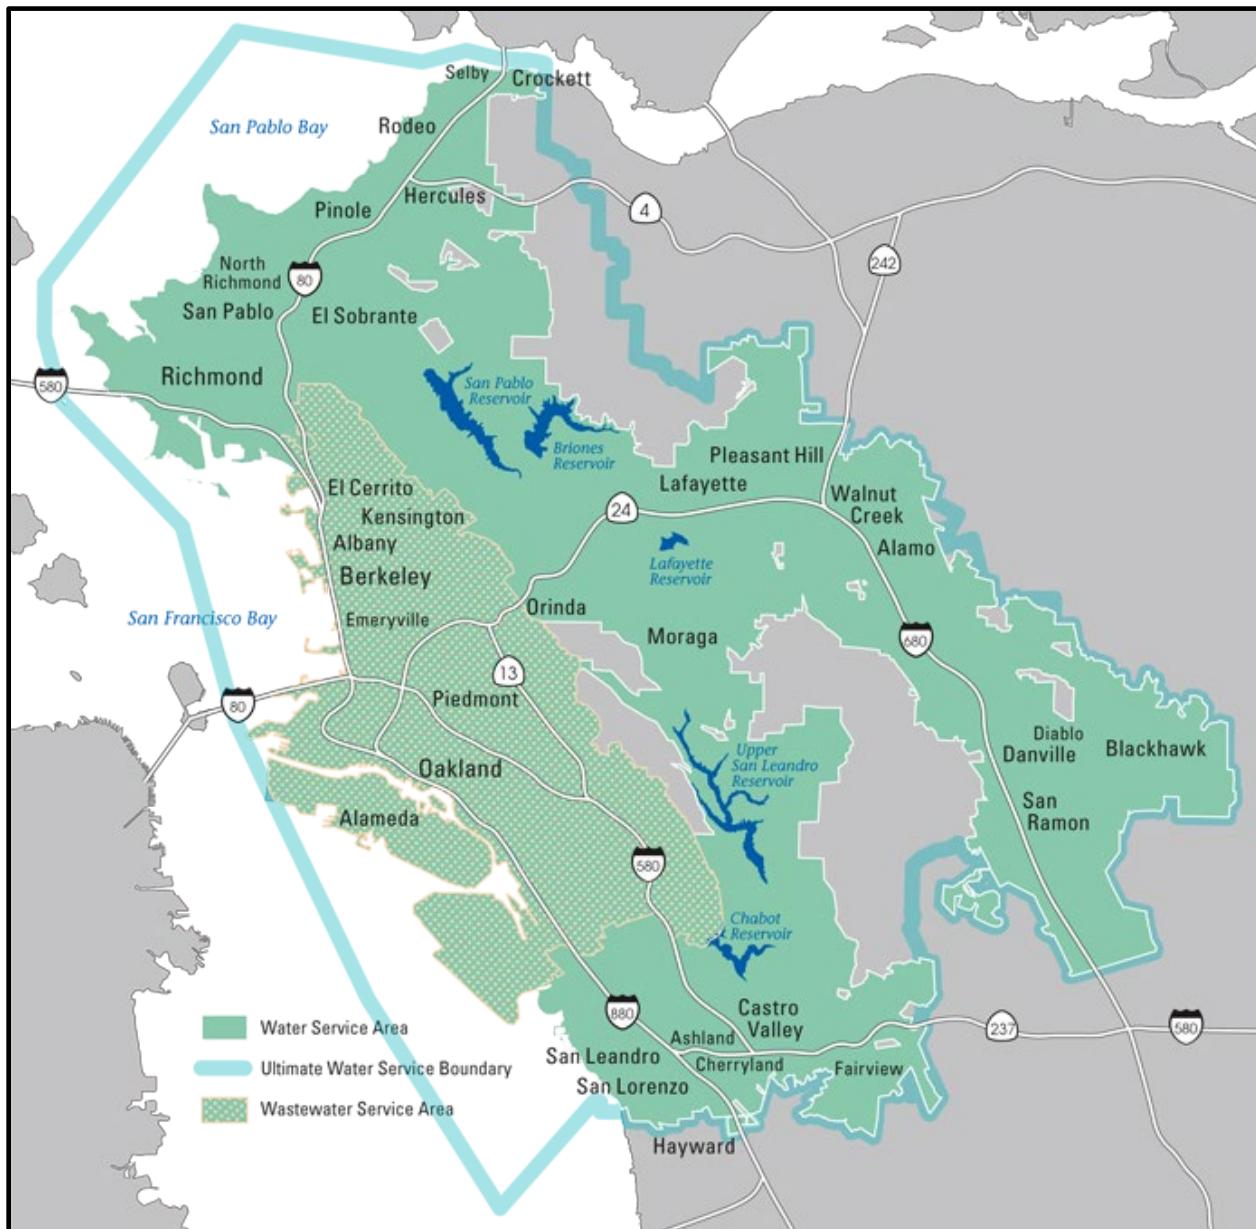
**Figure 11.2. EBMUD's Service Area**

EBMUD's water system serves approximately 1.4 million customers in a 332-square-mile area extending from Crockett in the north to San Lorenzo in the south (encompassing the major cities of Oakland and Berkeley), eastward from Oakland to Walnut Creek, and then southward through the San Ramon Valley. EBMUD's wastewater system serves approximately 676,000 customers in an 88-square-mile area of Alameda and Contra Costa Counties along the Bay's east shore, extending from Richmond in the north, to San Leandro in the south.
