SERVICE REPORT FOR UPPER BLOCK REPLACEMENT  
ENTERPRISE DGRS-46 ENGINE SERIAL NUMBER 82004-3063  
UNIT 2  
EAST BAY MUNICIPAL UTILITIES DISTRICT  
OAKLAND, CALIFORNIA

## INTRODUCTION

## SYNOPSIS

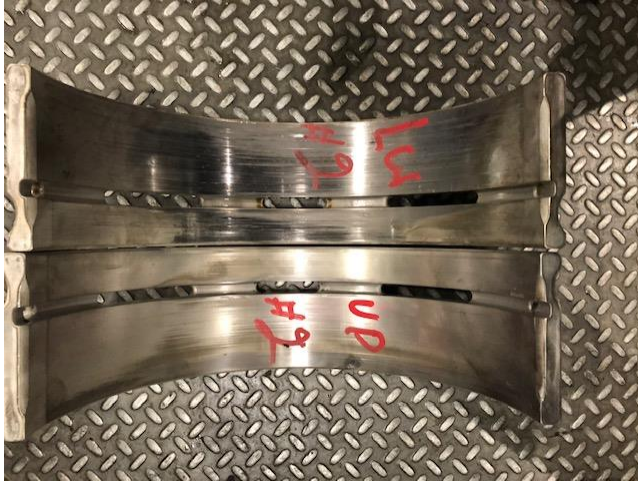
#3 Main bearing loading on lower shell. No debris transfer to upper shell.

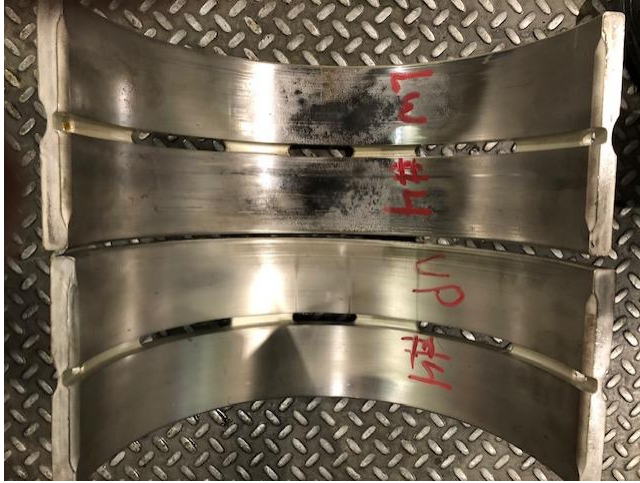
#5 Main bearing loading and overlay fatigue on lower shell

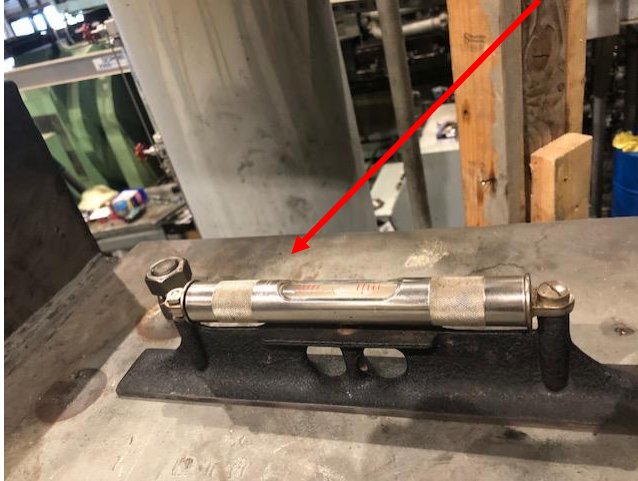
Turbocharger support bracket was found to have a rise in the middle of the bracket leaving the turbocharger support feet at an angle (leaving soft foot in the turbocharger). Planar measurements of the support bracket were .060 in/ft. and .050 in/ft. sloping upward toward the engine block.

Outboard exhaust side level out of range measured using feeler gauge .055.

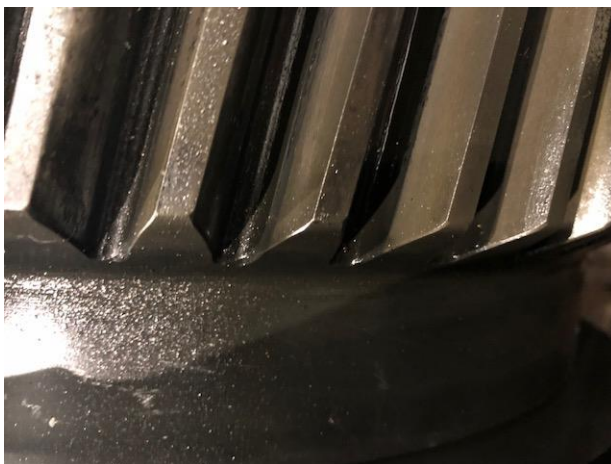
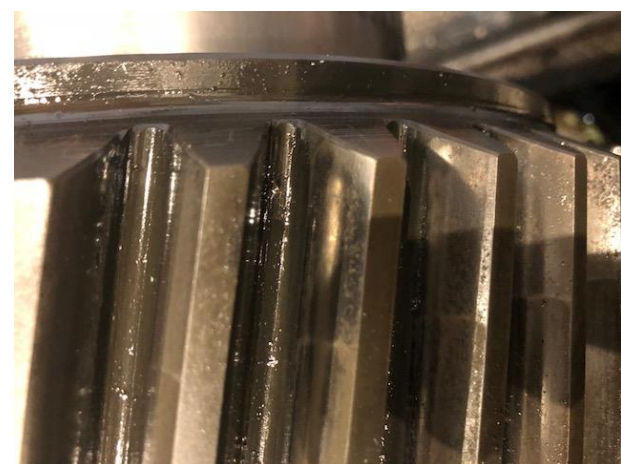
Crankshaft Gear Metal Particles

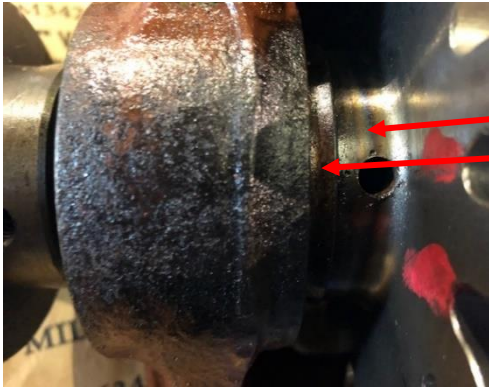
Coked oil and blued surface (carbon precipitate at surface) of gear due to heat.  
Flared bushing surface due to heat at contact point with the gear

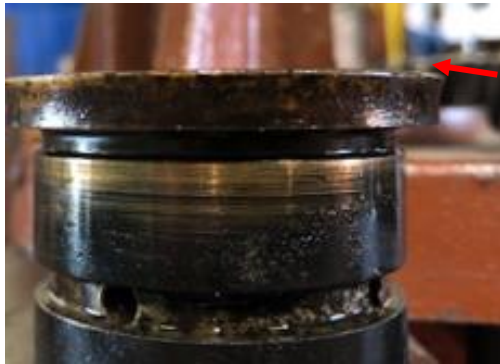
Flared end of front bushing at contact area with gear side.

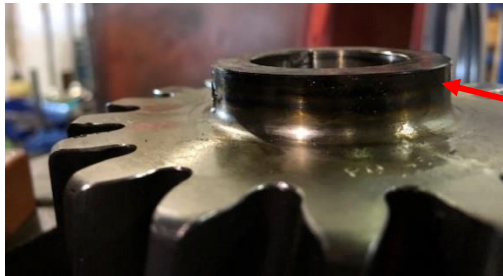
Blued steel from heat at contact point with bushing.

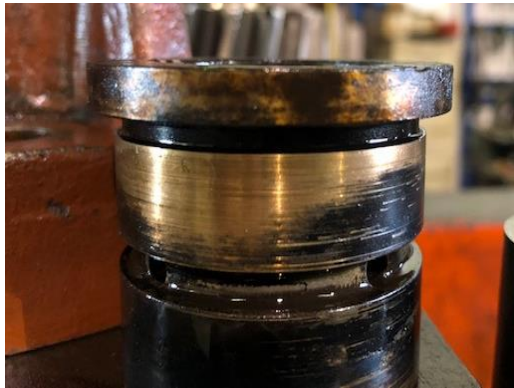
Rear bushing coked oil.

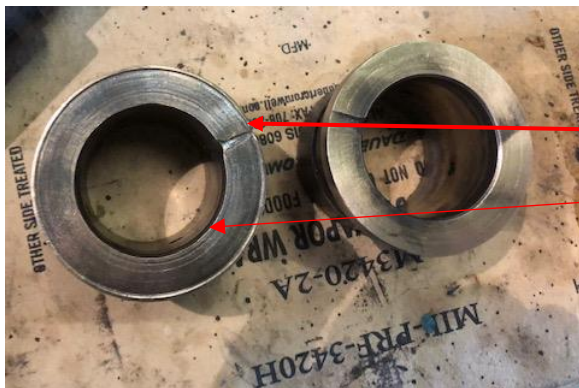
Front bushing melted metal at gear side contact

Both bushings have fine cuts from debris. (Should be smooth from years of lubricated operation)

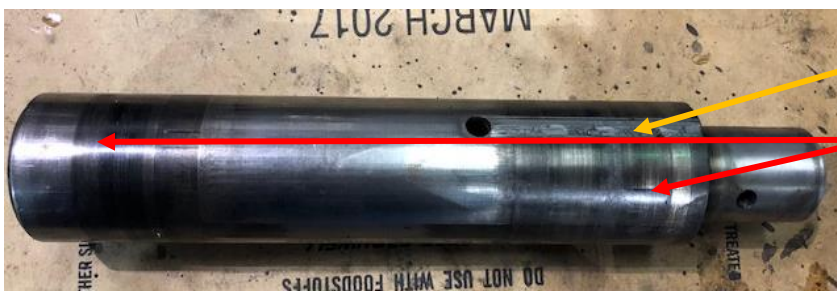
Scratch from disassembly

Blue steel from heat

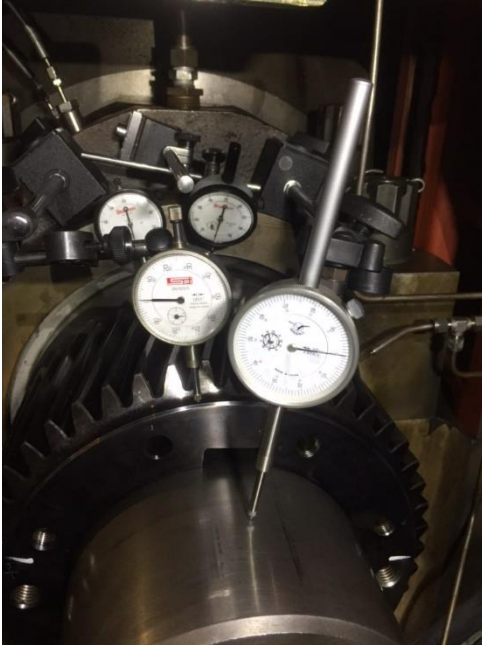
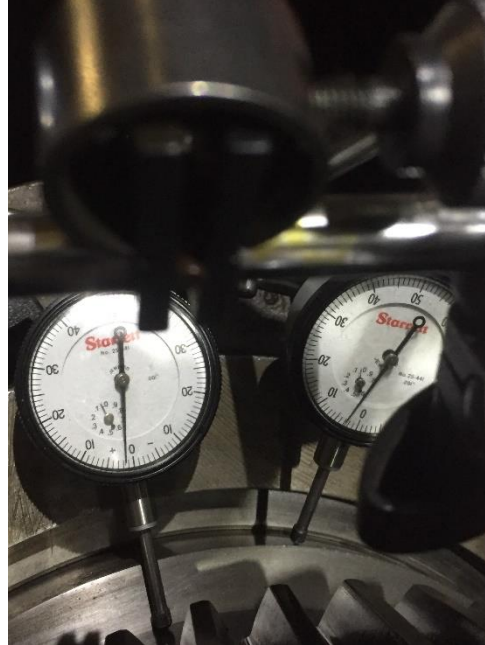
On 19-20 March 2019 runout measurements on the crankshaft found .019 deviation total indicated runout (TIR) using dial indicators (Starrett .001 in gradation). The TIR deviation indicates a bend at the end of the crankshaft of .009 from centerline. TIR taken at #1 main bearing journal measured .010 in indicating a bend of .005 from centerline at the crankshaft gear shoulder. Measurements taken at disassembly 05 September 2018 of the upper block, main bearing replacement, piston and rod assembly installation, and rear cover did not indicate a bent crankshaft. Deflection readings for #1 crankpin were +.0025 on bottom and +.0005 on top both within specifications. Reassembly crankshaft deflection measurements on 14 September 2018 at #1 crankpin were +.001 on top and +.001 on bottom. Main bearing clearance for #1 and #2 main bearings were .010 and .010 respectively (specification .008-.014).

A, B, C, D position 1. All indicators reading 0    C, D Position 2 Indicators reading .0015 and .0035

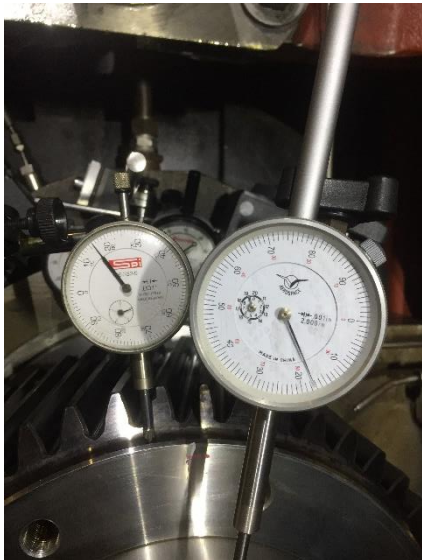
A, B position 3 indicators reading .017 and .016

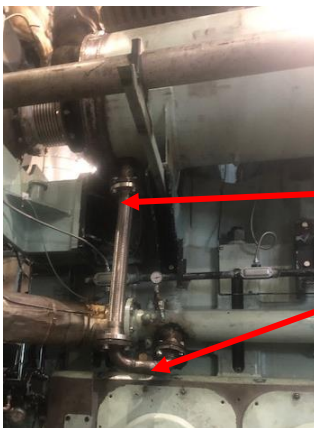
← Water supply flex pipe using flange fittings on both ends from upper block water inlet header to exhaust water jacket inlet.

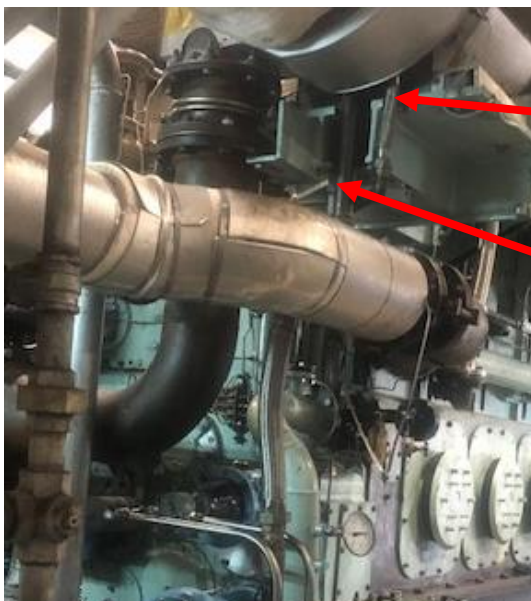
Unit start up on 23 August 2019 found the turbocharger oil supply pressure was running at 23 psi at 661 kw. The starting turbocharger was 33 psi with no load. 24 August 2019 disassembly of the turbocharger drain line was performed on units #2 and #3 to locate an orifice to raise turbocharger oil supply pressure. 26 August 2019 oil supply inlet piping was removed from units #2 and #3 to compare the inlet oil supply orifice size. The inlet oil supply orifice was removed from unit #2 and opened to .375 in.

Turbocharger inlet oil supply piping

Turbocharger oil drain line

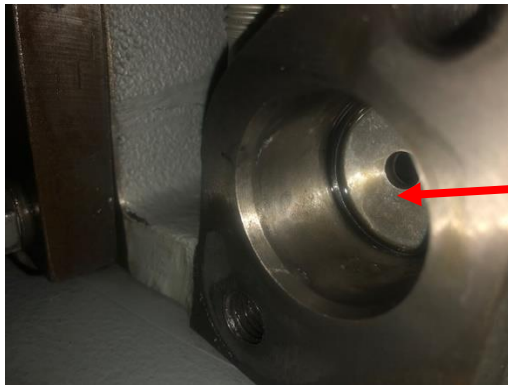
Turbocharger inlet orifice

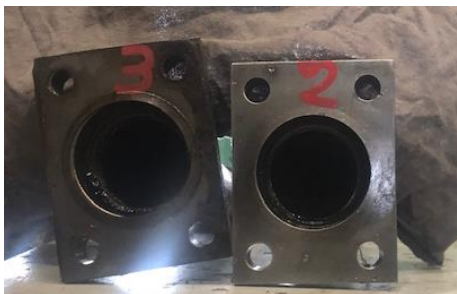
Turbocharger inlet supply line unrestricted.

Turbocharger drain lines from Units #2 and #3 unrestricted.

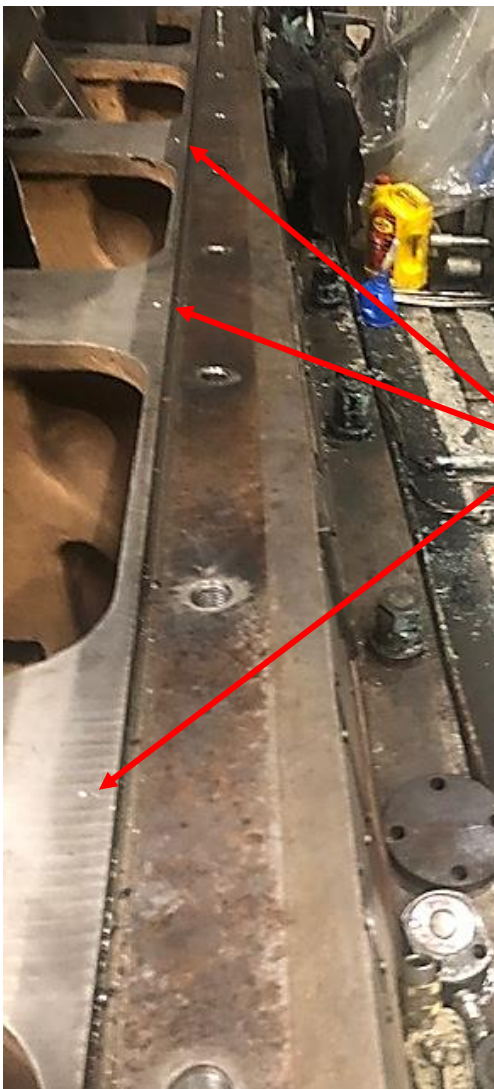
RIGHT BANK INTERVAL POINTS 600mm (23.622 in)

Engine base right bank interval points  
(paint marker points) at 600 mm (23.622 in) set center line to main  
bearings.

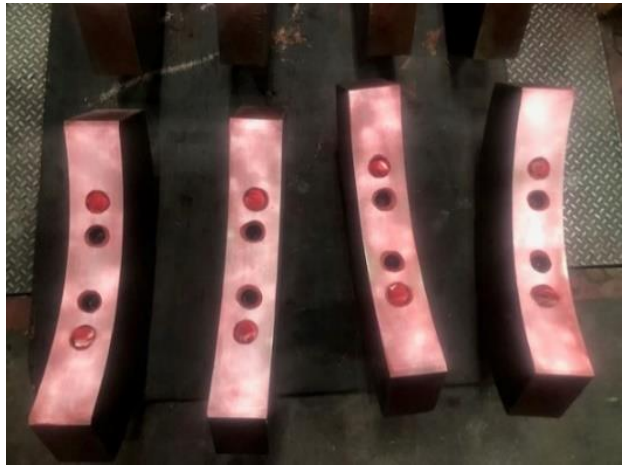
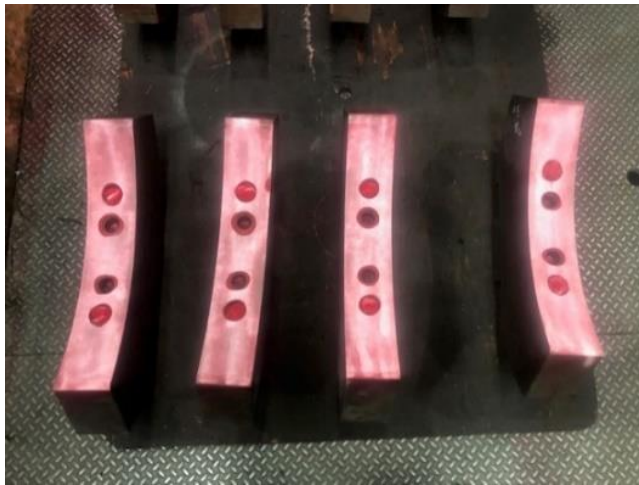
Die Penetrant NDT (SPOTCHECK SKC-S Aerosol (cleaner); SPOTCHECK SKL-SP2 Aerosol (penetrant); SPOTCHECK SKD-S2 Aerosol (developer). Die penetrant inspection did not find any cracks or fretting on the counterweights bases to crankshaft web shoulder. (2 counterweights per crankpin throw)

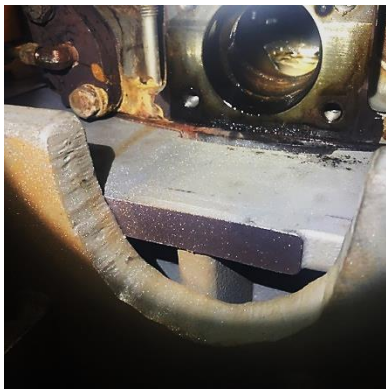
#3 TURBOCHARGER DRAIN

Remove turbocharger drain lines from Unit #2 and #3 to find a reported missing orifice plate to reduce oil flow drain and raise oil pressure in the turbocharger. No orifice plates were found in either turbocharger drain line. The drain lines were put back on to Units #2 and #3 and #3 restarted. #3 air intake horn was removed and resealed on Unit #2. Fuel injection line clamps were installed on the 6 fuel injection lines to the fuel injectors on Unit #2. Provided are pictures of the turbocharger drain lines from Units #2 and #3.

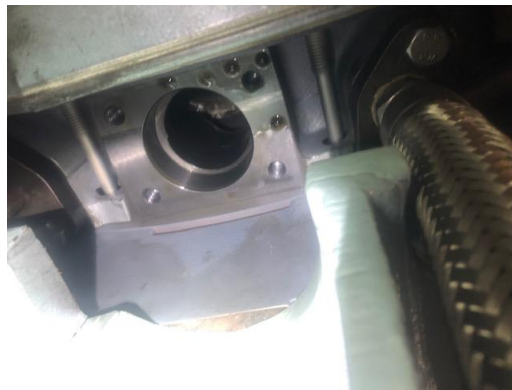
#2 TURBOCHARGER DRAIN

Units #2 and #3 turbocharger drain line pipes.

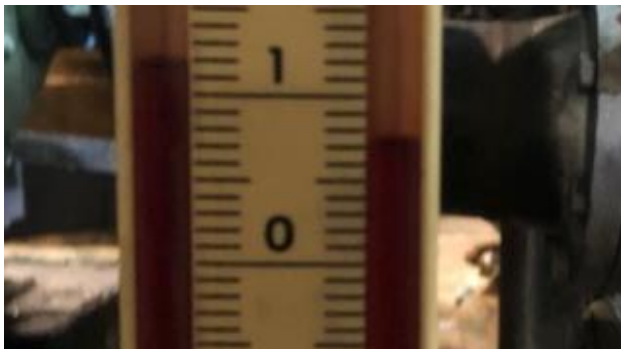
Run unit at 2100 kw for 3 hr. Run unit at 2300kw for 1 hr take firing pressures, shutdown and take hot crankshaft deflection, crankcase inspection and geartrain inspection. Remove #4 cylinder head intake air horn, replace gaskets to fix air leak. Continue to look for cause of crankcase vacuum pressure being higher than other units Put covers back on crankcase (-.5 in crankcase pressure after replacing #3 cylinder head)

Crankcase vacuum at 2300 kw dual fuel.

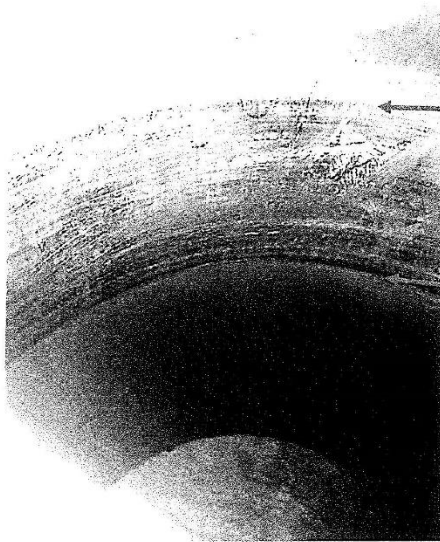
UNIT 2 CYLINDER #4 LOWER BORE

← COMPRESSION RING STOP TOP NO TRANSITION

← OIL RING STOP BOTTOM NO TRANSITION

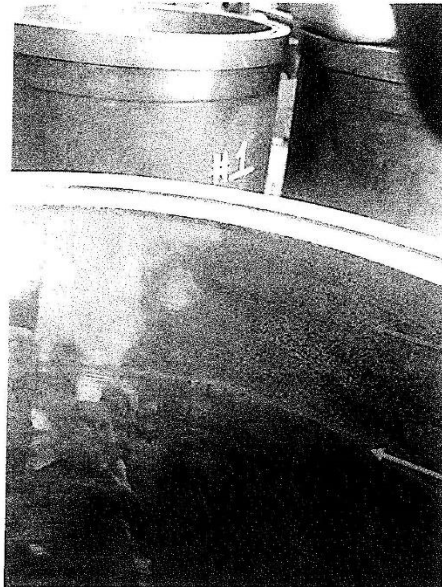
UNIT 2 CYLINDER #3 UPPER BORE

RING STOP AREA NO TRANSITION IN SURFACE

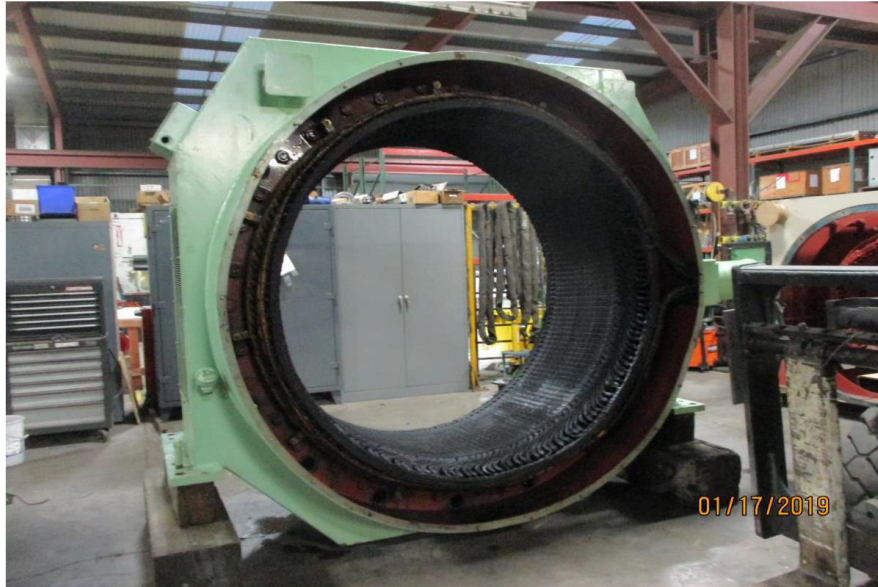
As Found ~ Stator

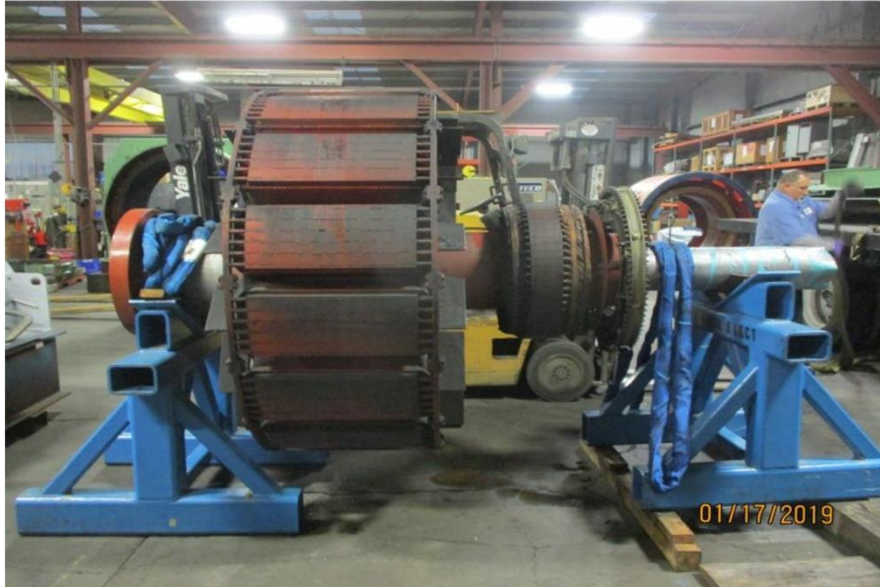
As Found ~ Rotor

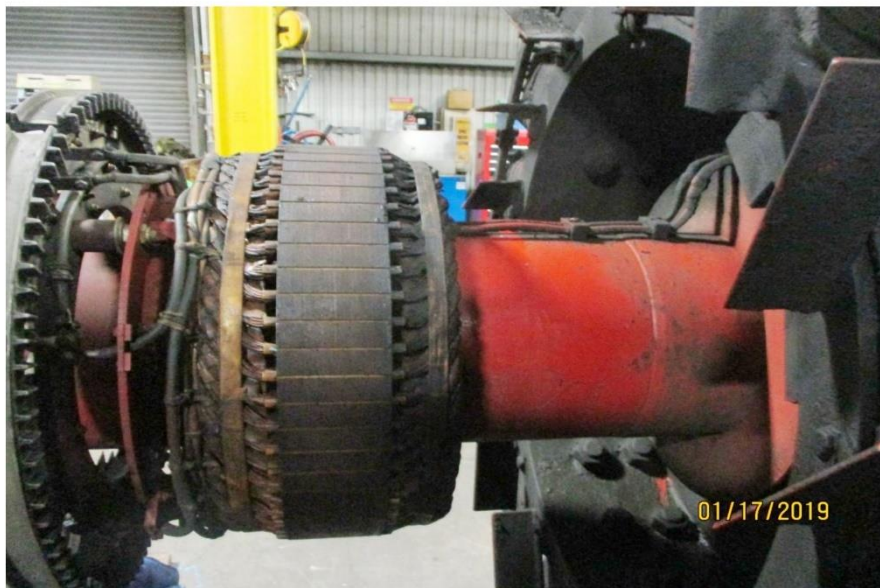
As Found ~ Exciter

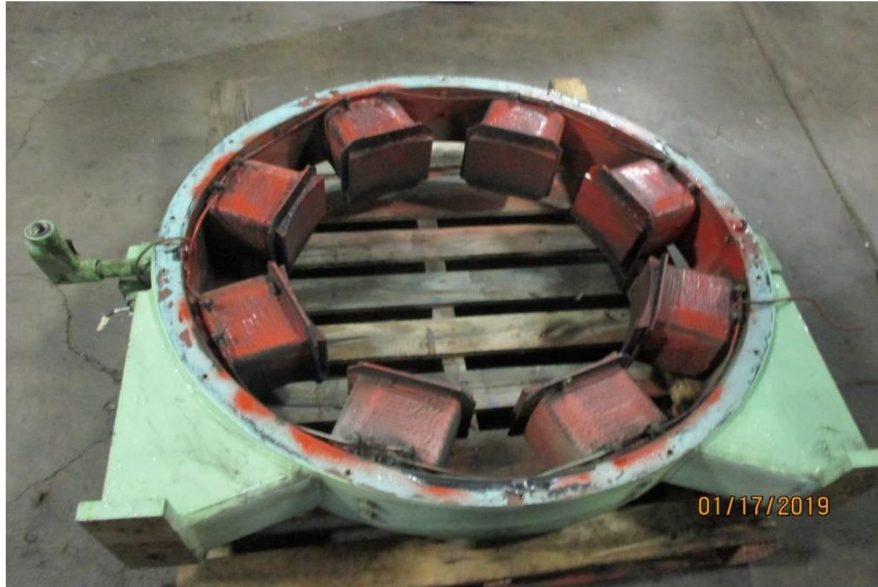
As Found ~ Field Frame

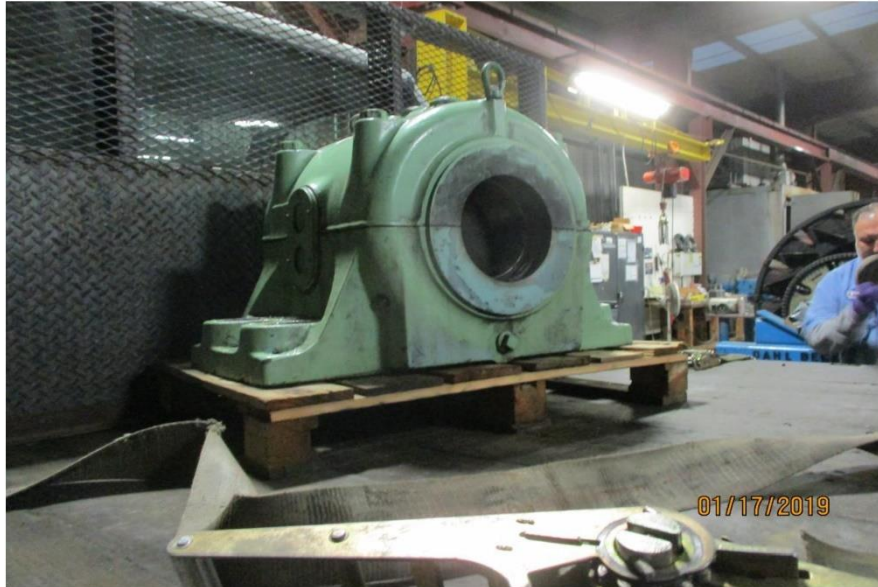
As Found ~ OPE Bearing Housing

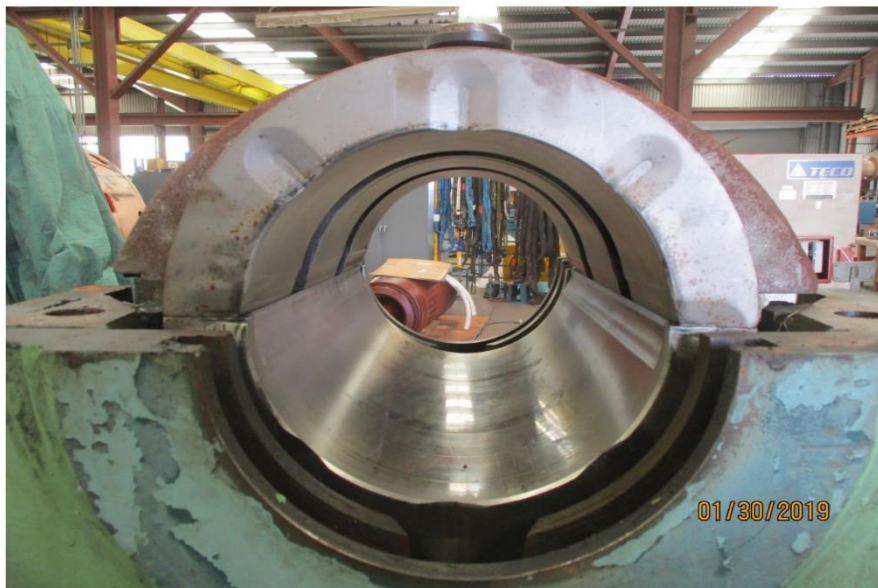
As Found ~ OPE Housing

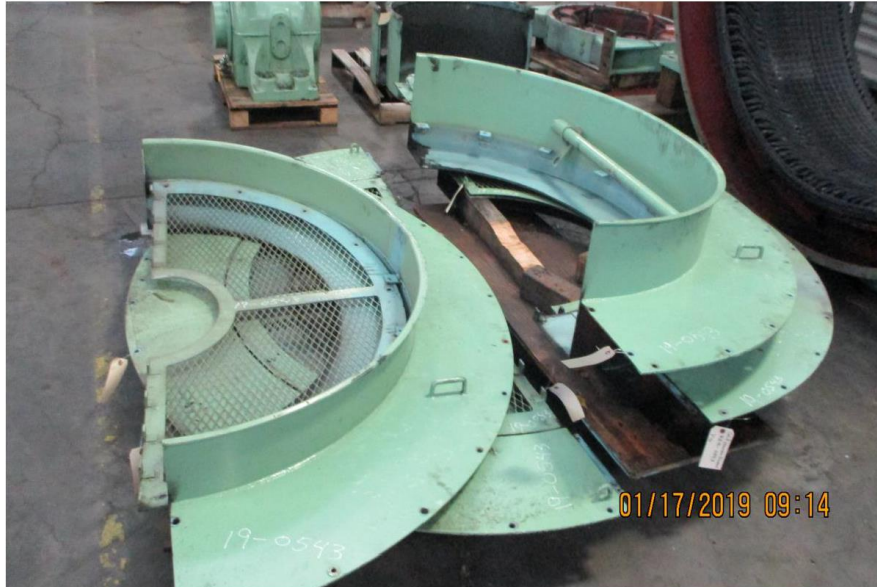
As Found ~ Covers
